TECHNICAL REPORT N-70-10

**SURVEY OF GULF COAST  
STRUCTURAL DAMAGE RESULTING FROM  
HURRICANE CAMILLE, AUGUST 1969**

**M. E. Criswell, R. S. Cummins**

**April 1970**

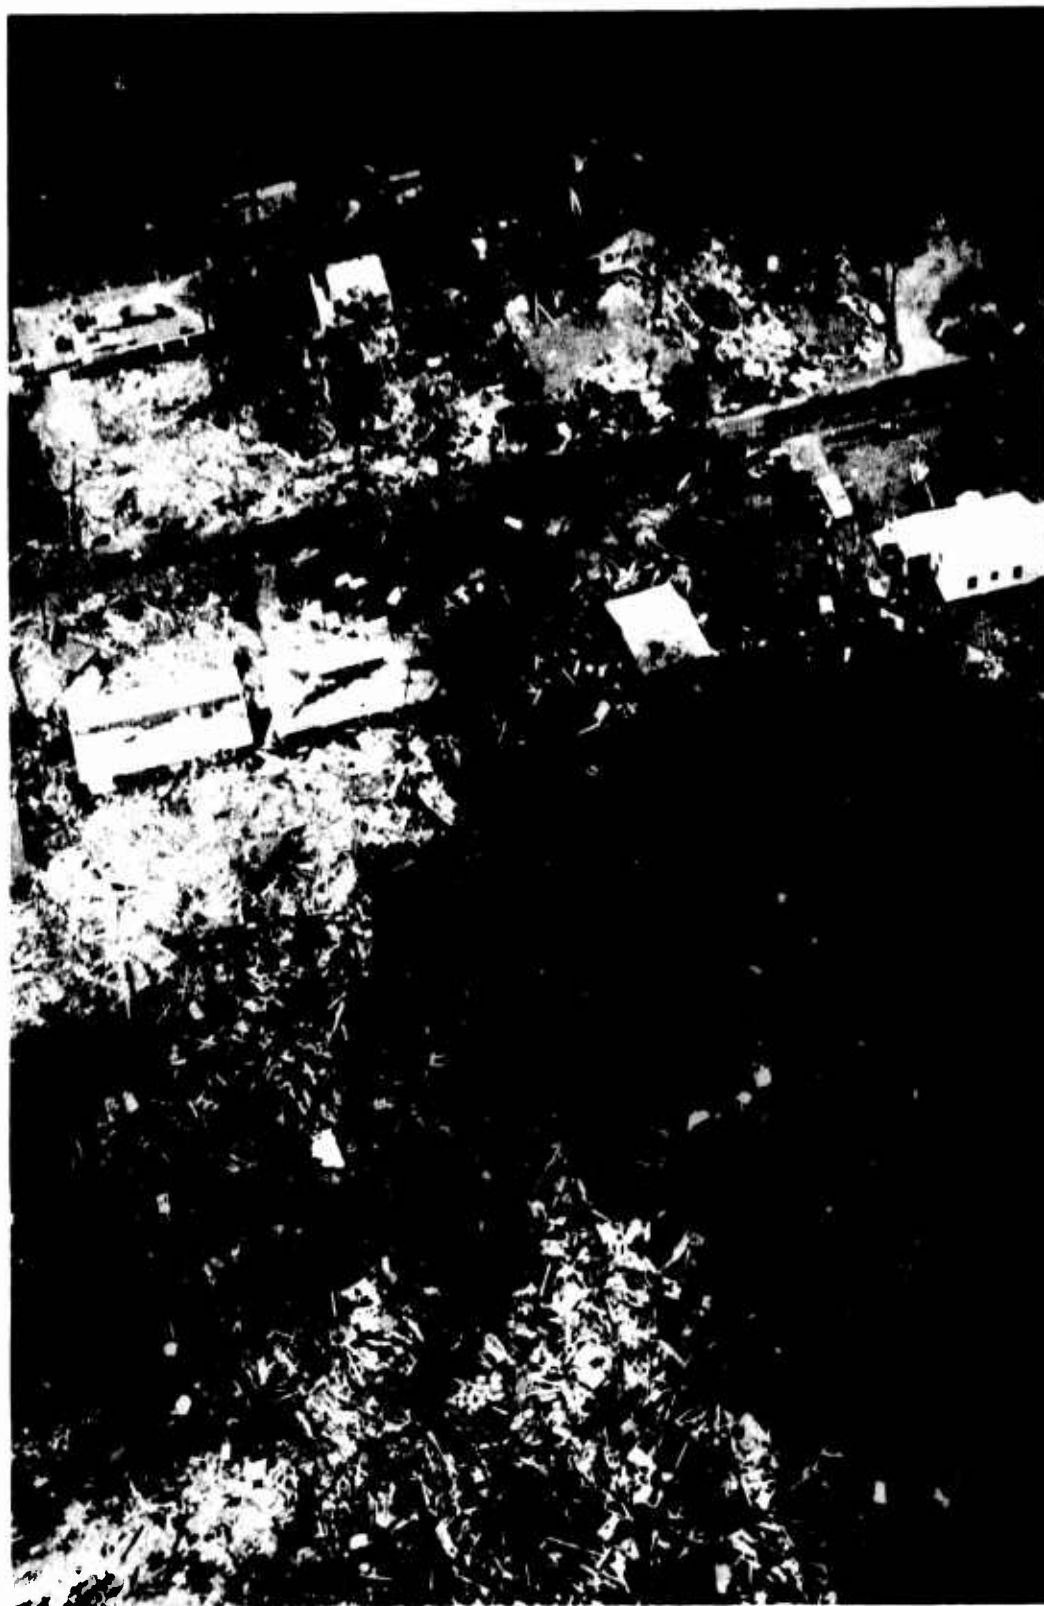
The extent of debris deposited inland marked the limit of greatest tidal action. The debris line is clearly seen in Figure 2.17.

Figure 2.17 Residences and debris line in west Gulfport, Mississippi.

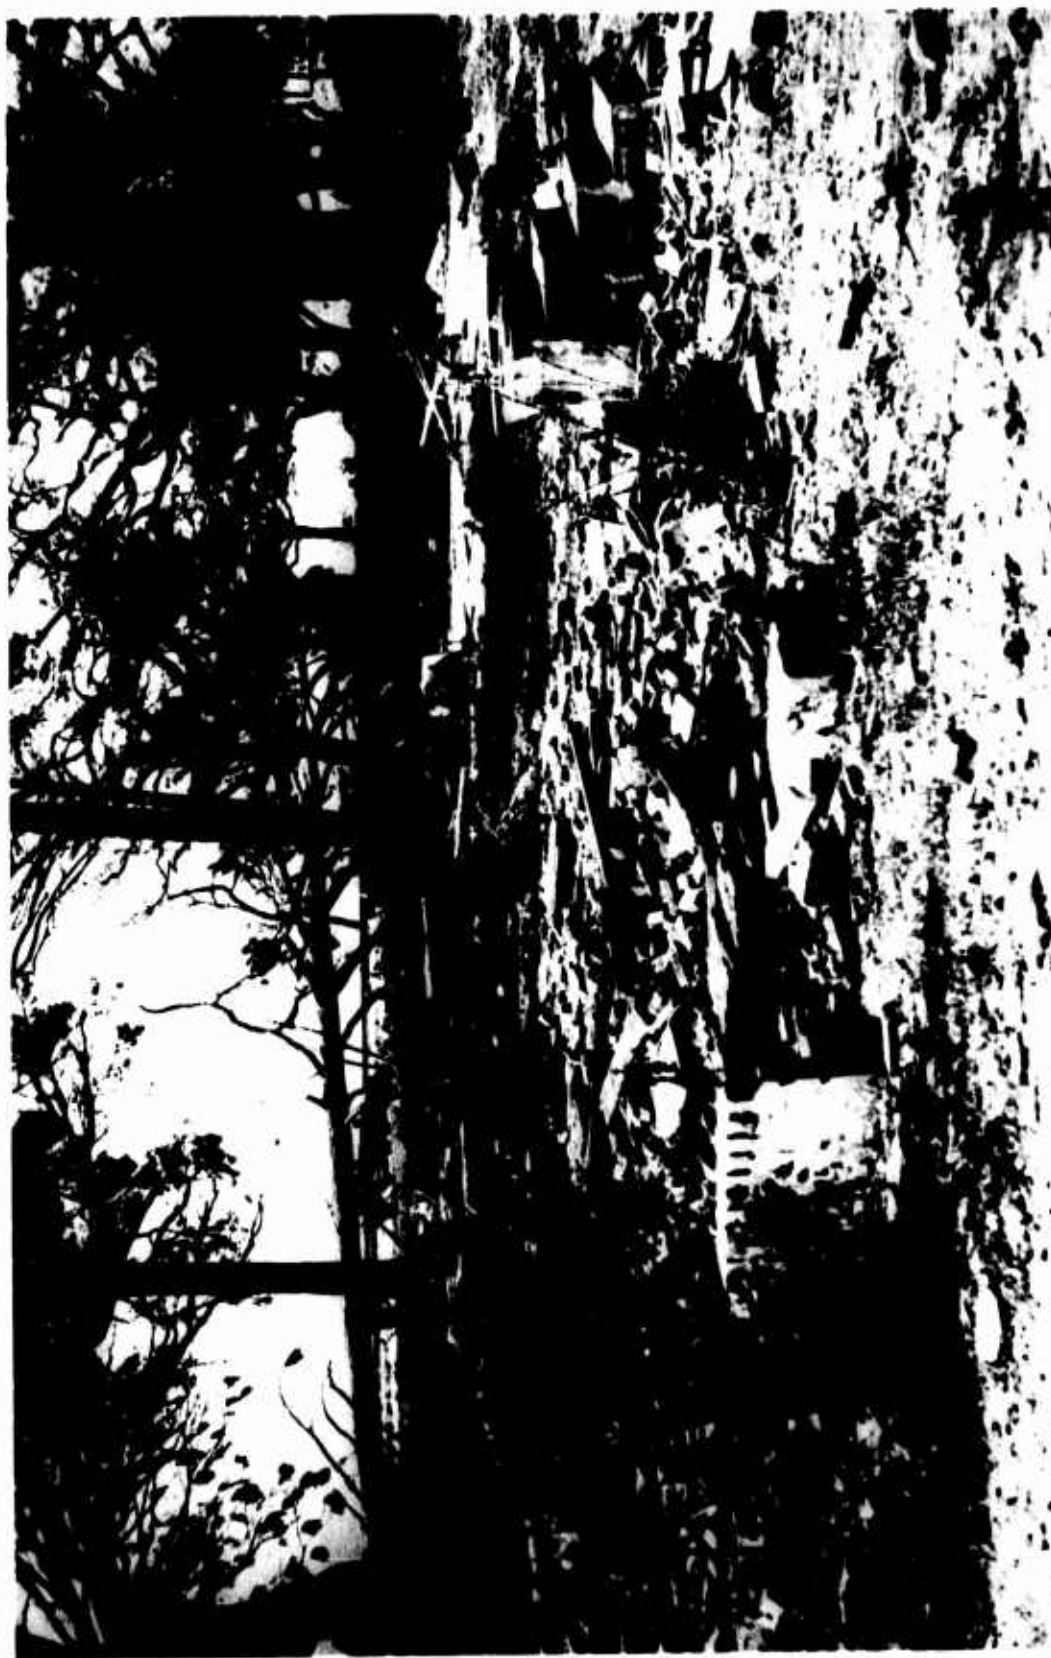
Figure 2.35 Residence near Long Beach, Mississippi.
